BEAM REVIEW
Argyle Community Centre
10812 Hwy 522
Arnstein, Ontario

Submitted on: September 19, 2018

TPE18-0742

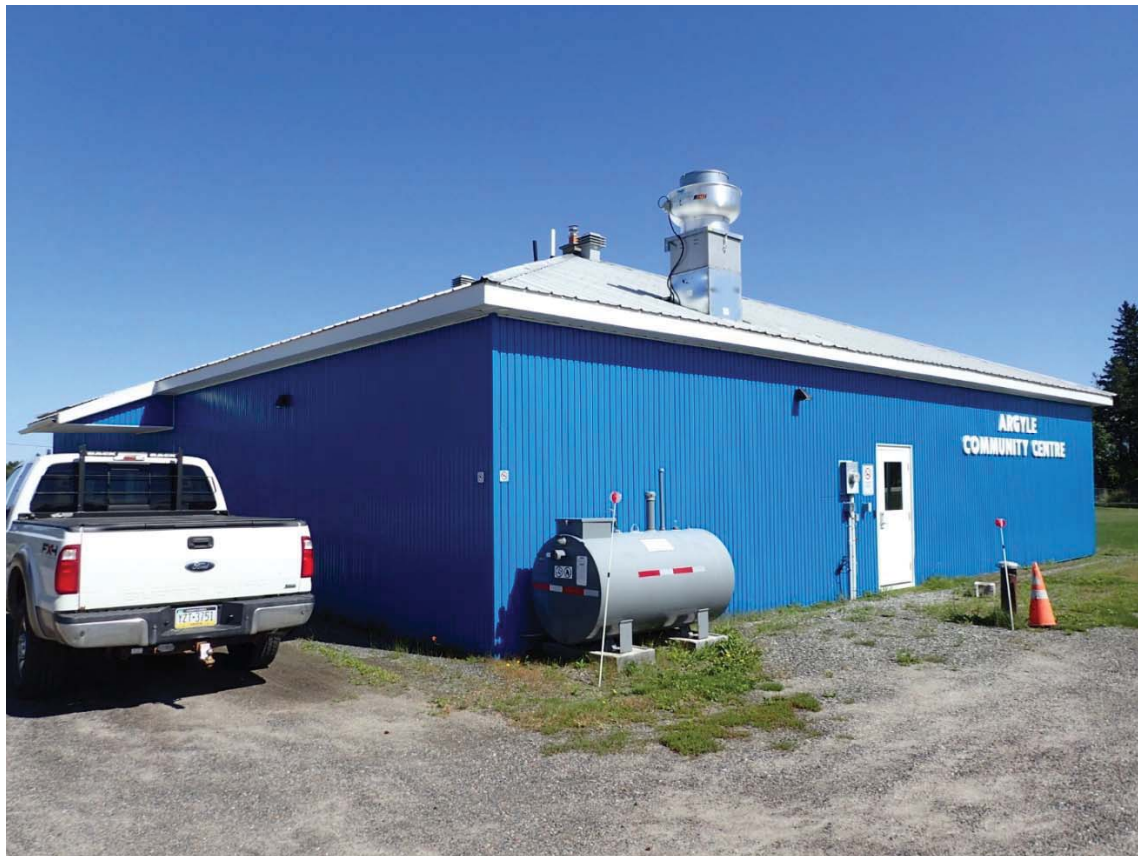
The subject property is located on the north side of Highway 522. The building is a one-storey structure with a hip-style roof (see Photo 1).

Photo 1: View of the front of the community centre.

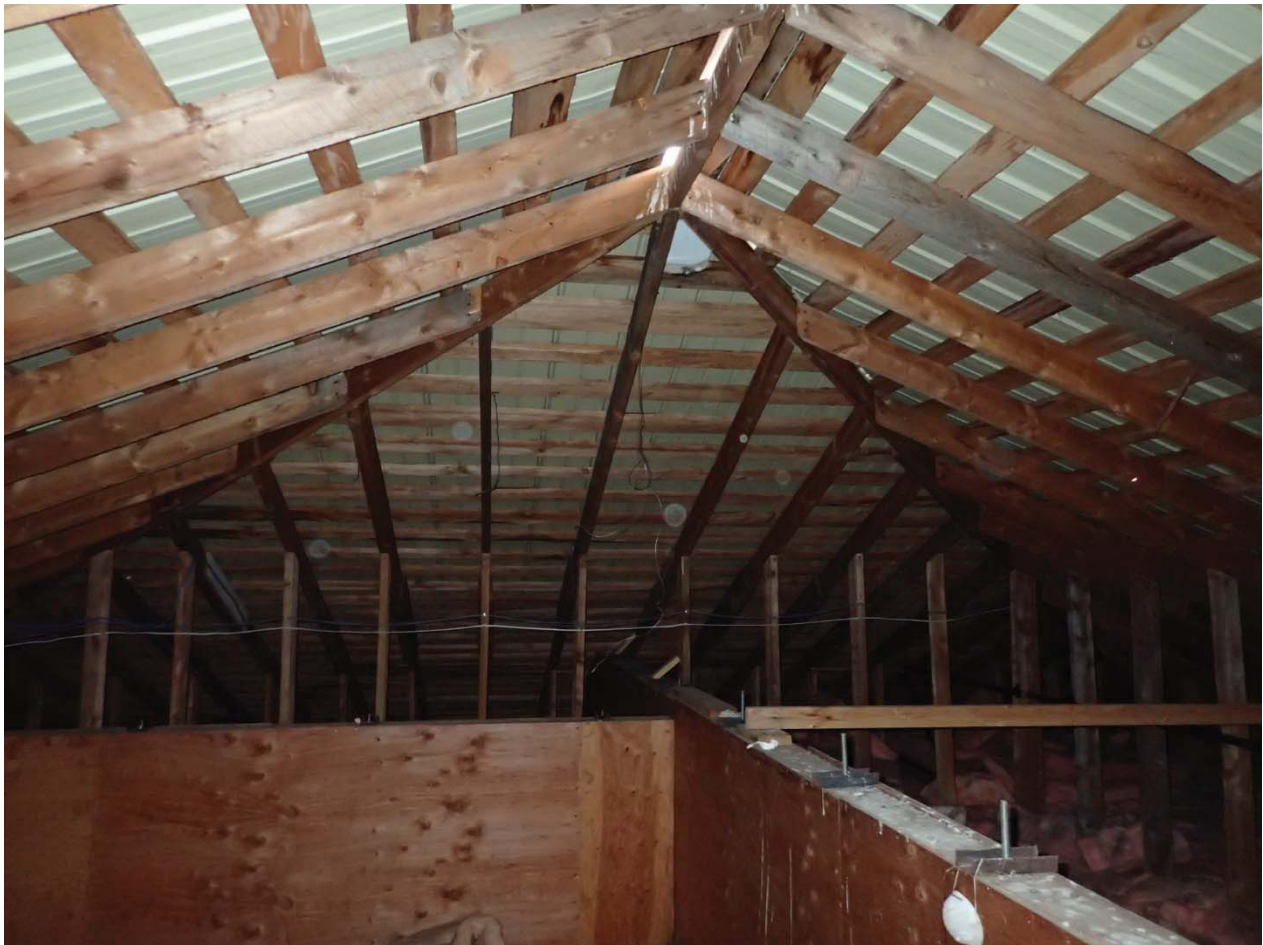
1. The roof is framed with rough cut timber (Refer to Photo 2). Metal roofing is applied directly to strapping on the rafters. The rafters are supported on struts extending to the ceiling framing (refer to Photo 3). The strut locations do not correspond to a wall location below – they are support by the ceiling joists. In some areas, the ceiling framing consists of the original structure's flat roof. Ceiling joists are visibly sagging on the north side of the hall area.

Photo 2: Roof framing viewed from the attic. Note the struts visible in the background.

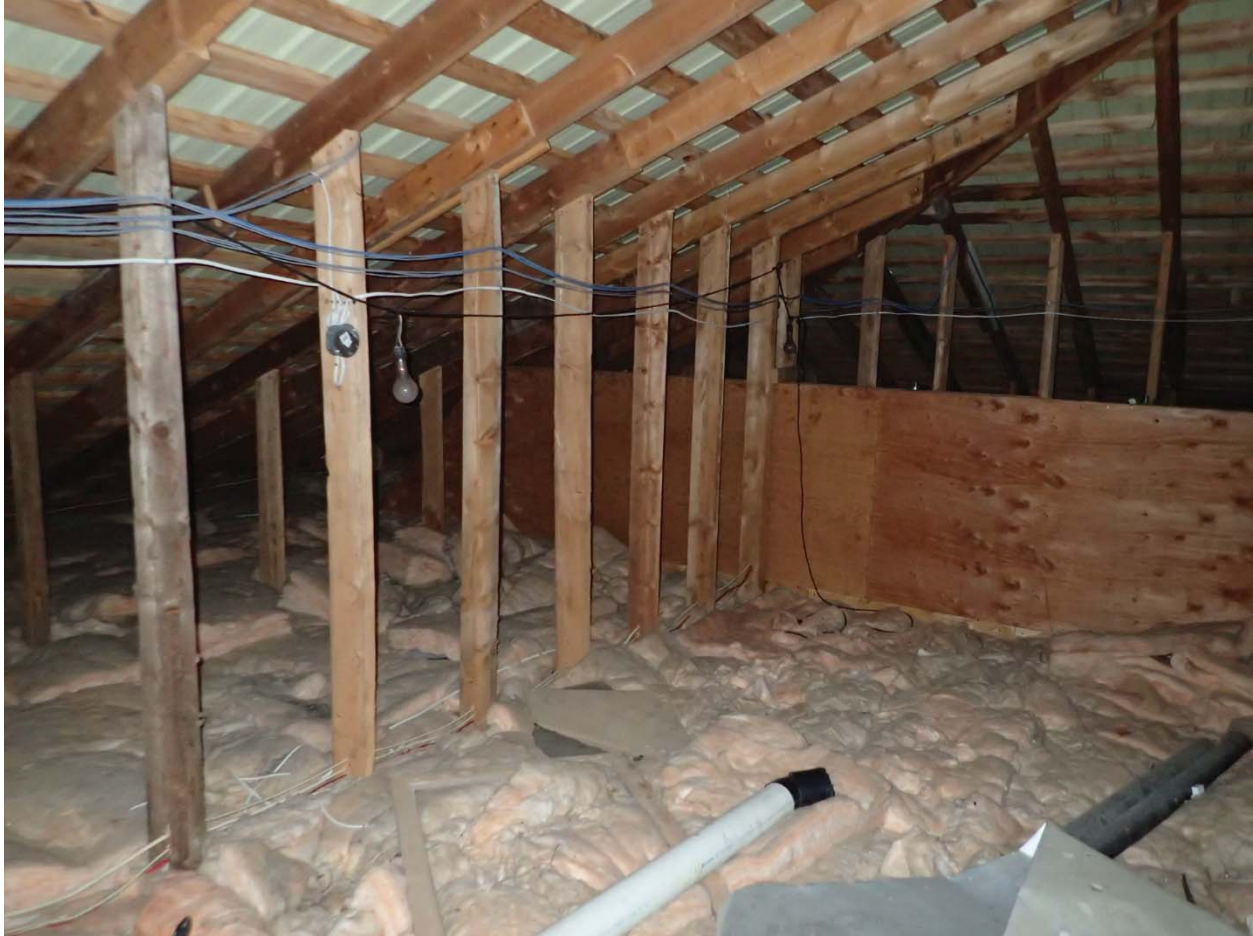
Photo 3: Struts supporting the roof rafters.

Further, it was observed that the roof rafters are supported by mid-span struts bearing on the ceiling joists. It is likely that this is the cause of sagging of the ceiling joists on the north side of the building. With the roof supported by the joists and the joists hung from the beams, it can be concluded that the beams support all roof and ceiling loading via the hanging connection. **This is not a common form of construction and without significant destructive investigation, the capacity of the roof, ceiling joists, and their connections cannot be determined.** It should be noted that in our experience ceiling joists do not typically have sufficient capacity to safely support roof loading in this manner.

Temporary use of the building may be possible if shoring is erected to support the beams. However, until the capacity of the roof and ceiling is confirmed as discussed above, the building cannot be safely occupied during the winter months due to increased loading on the roof from snow.

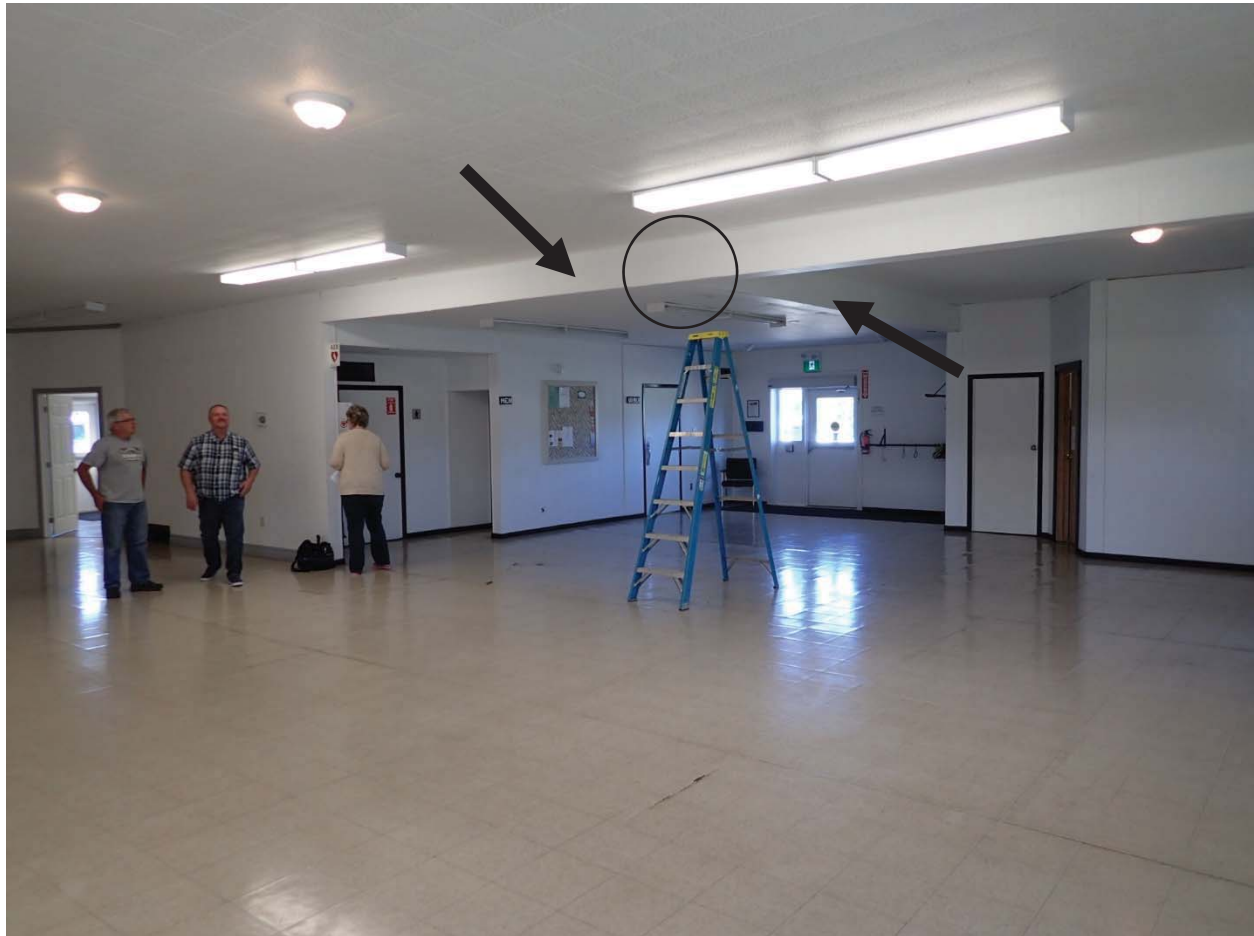
2. From within the hall area, it appears the ceiling is supported by a beam spanning approximately 35'-0" with a secondary beam supported at mid-span, approximately 24'-0" in length. Bulkheads extending down from the ceiling surface indicate the perceived beam locations. Refer to Photo 4.

Photo 4: The main hall area. The two bulkheads are denoted by arrows; the area where finishes were removed is denoted by the circle.

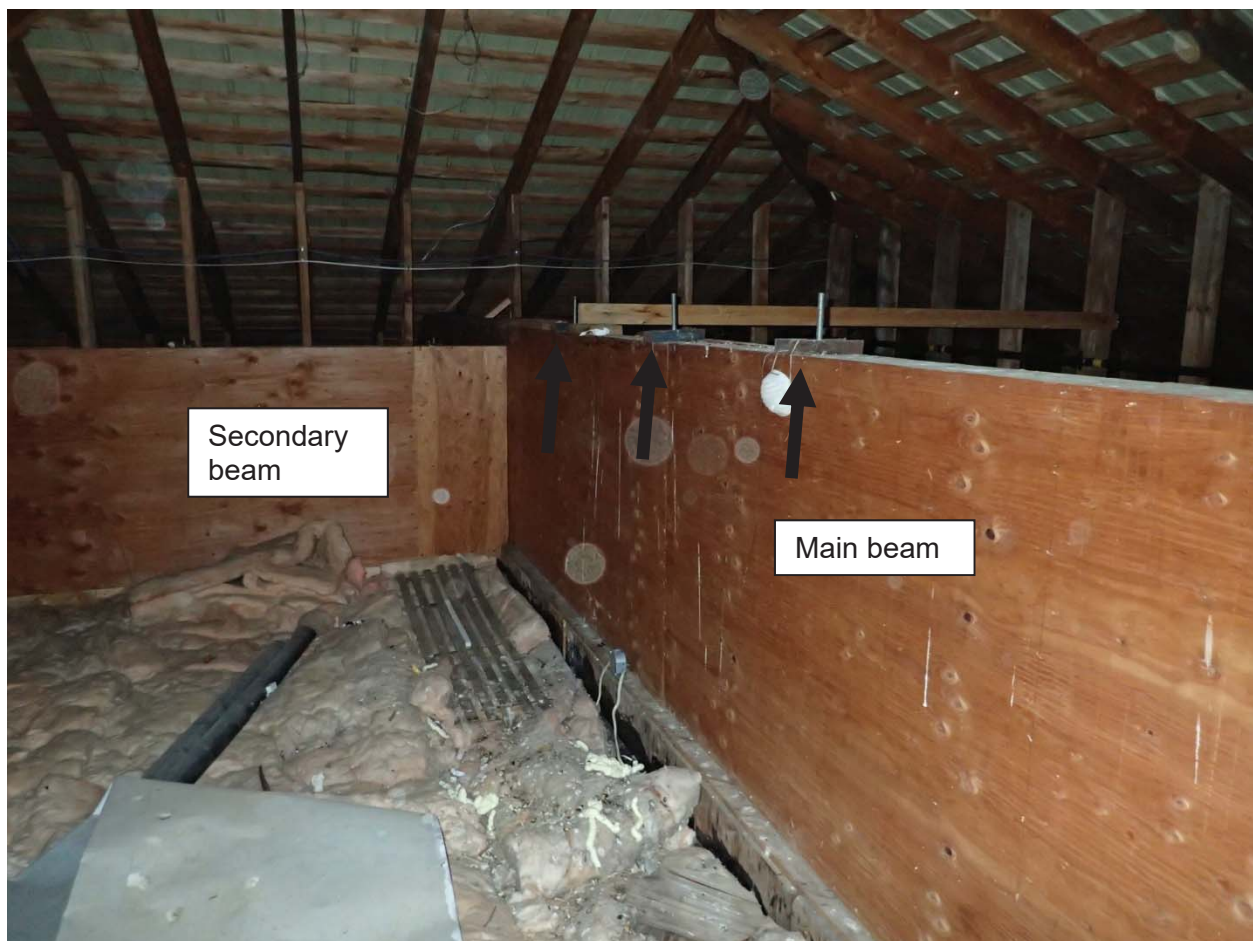
3. Despite the bulkheads in the hall area giving the appearance of beams, when finishes were removed, no beams were found. From within the attic space, it was apparent that the ceiling is supported by 4'-0" deep custom wood beams constructed of sheathed studs. Refer to Photo 5. The beams are built above the ceiling framing.

Through the depth of the beams, threaded rod was installed with heavy-duty washers, top and bottom, to hang the ceiling joists (refer to Photos 5 and 6). The "washers" are sections of 3" steel channel. The bulkheads observed in the hall covered the bottom washers and rod ends.

It was observed that the second beam has slipped relative to the main beam at the connection point and ceiling finishes along the length of the main beam were buckled.

Photo 5: Beams viewed from the attic space. Note the black roofing tar visible on the floor still present on the original school roof area. Some rod locations have been indicated with arrows.

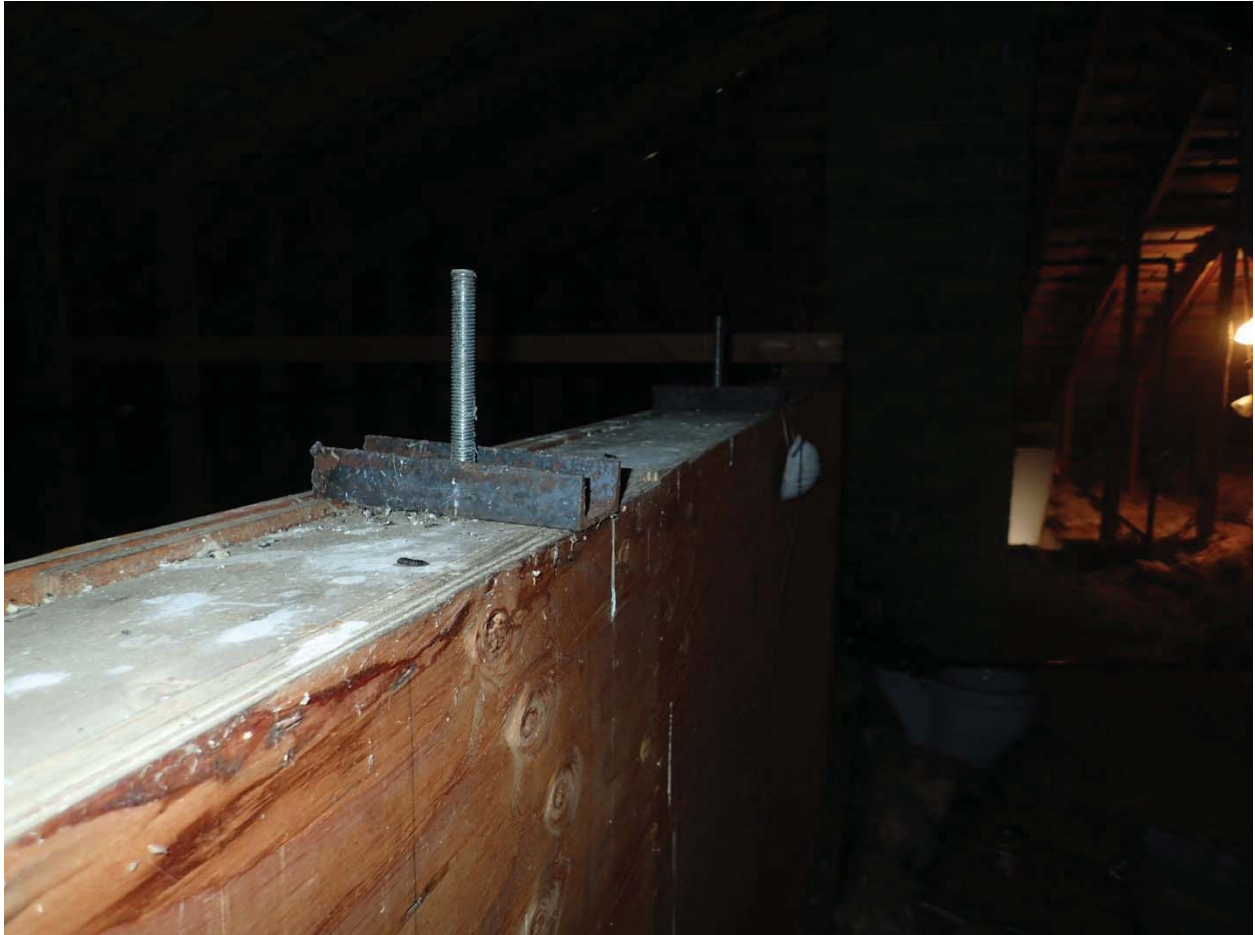
Photo 6: One rod and heavy-duty washer.

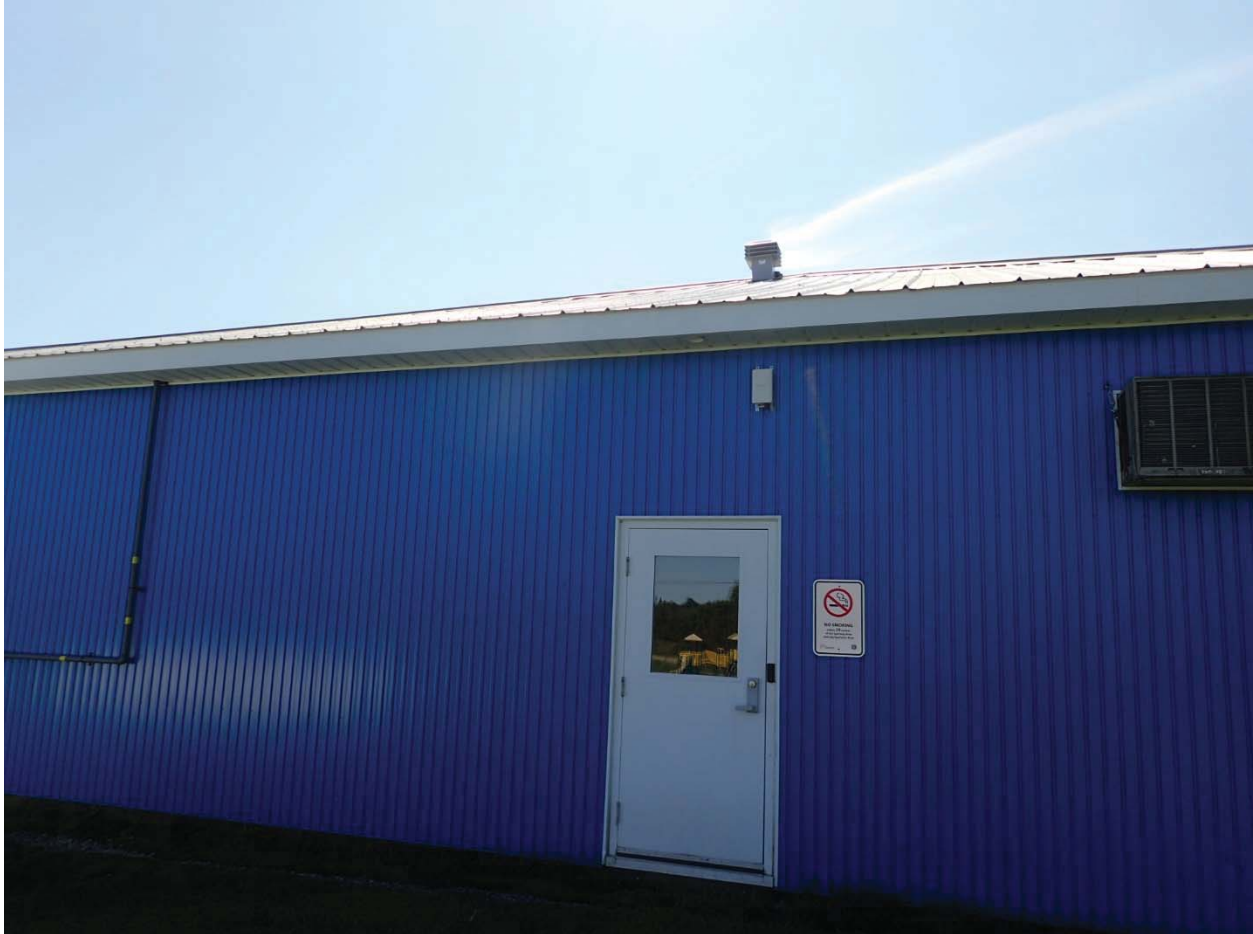
4. The north ceiling joists appeared to have a significant sag as did the roof above (when viewed from the exterior of the building). Refer to Photo 7.

Photo 7: The north face of the building.
