December 19, 2018

Project No: 18-67

Reference: Argyle Community Centre

Subject: Final Report Roof Structure Evaluation

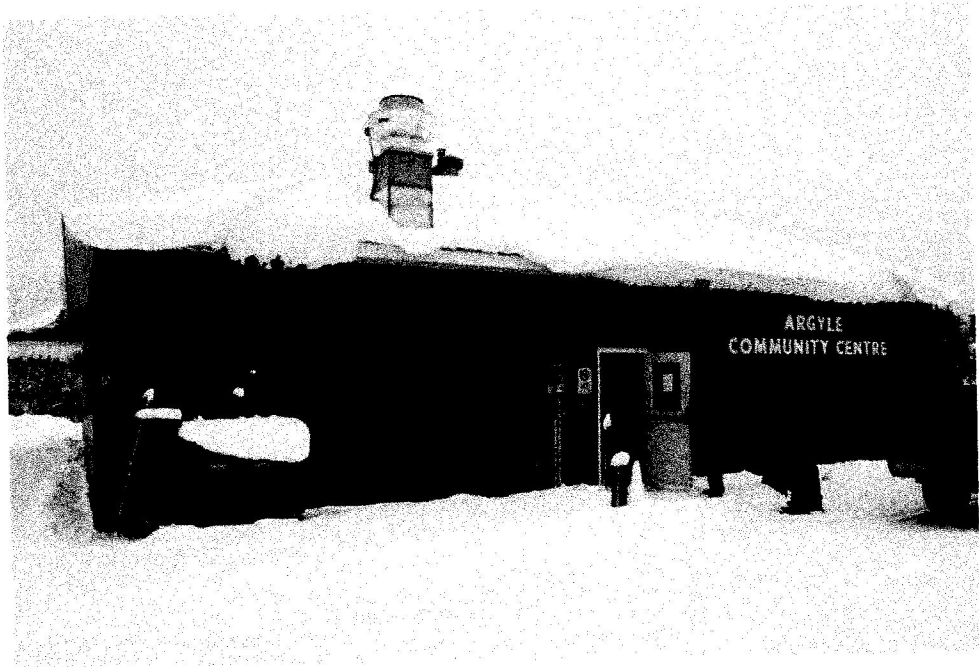
1

The one storey building is situated on the north side of highway 522. (See Picture 1). We were informed that it was originally a 'T'-shaped school building with the top of the 'T' on the east side (running north-south). A major renovation was done by local community members approximately 25 years ago, when additions were added to the northwest and southwest corners resulting in the current square footprint. The renovations also included the installation of a main north south plywood box beam girder, an east west plywood box beam, and a new hip roof that was built over the entire structure. (See Pictures 2 & 3).

South Elevation, Facing Highway 522
